REV. NO.		DATE	DESCRIPTION OF REVISION	BY	APP	TITLE <b>Gutter Outlet Tube Detail</b>	
DWG. NO.				DR	KRK	DATE	9/30/2025
				APP		DATE	
				SH. SIZE	B	SCALE	X:X

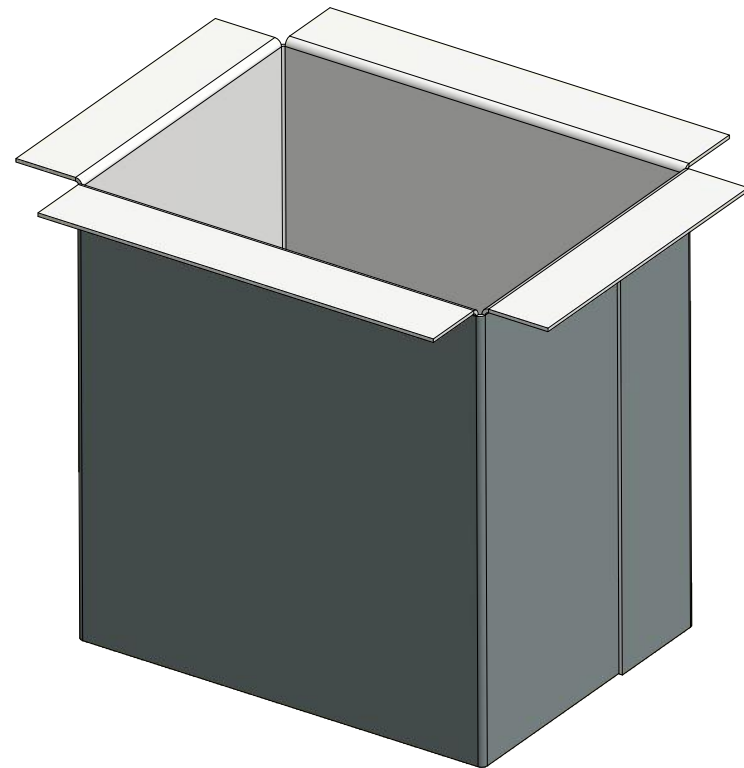
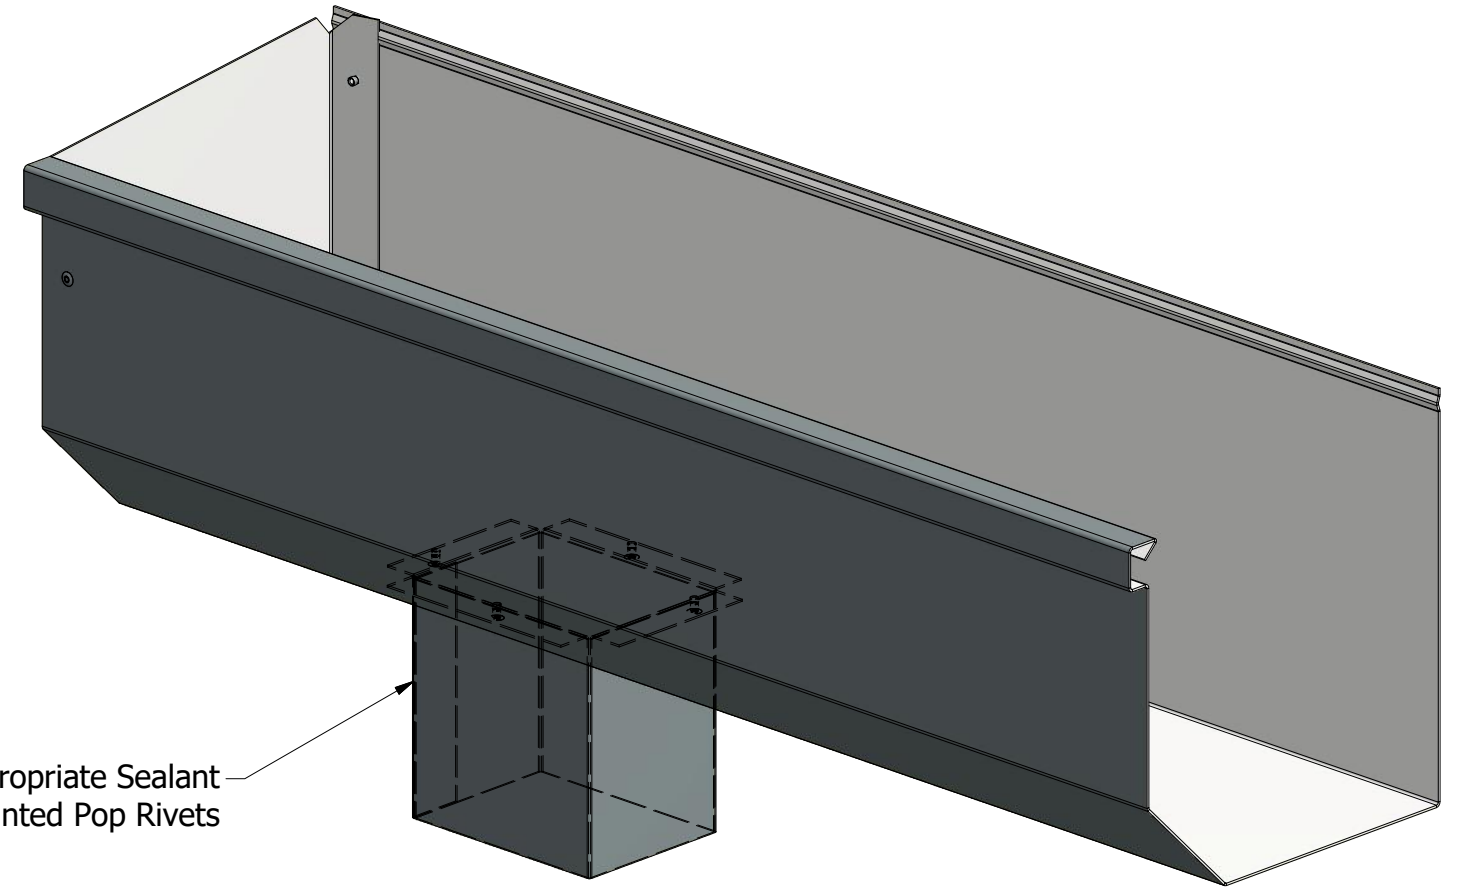
Set Outlet Tube in bed of Appropriate Sealant and secure with S.S. Painted Pop Rivets
